UNDERWATER BRIDGE INSPECTION REPORT

STRUCTURE NO. L0885

OTTER TAIL RIVER

MINNESOTA DEPARTMENT OF TRANSPORTATION
UNDERWATER BRIDGE INSPECTION

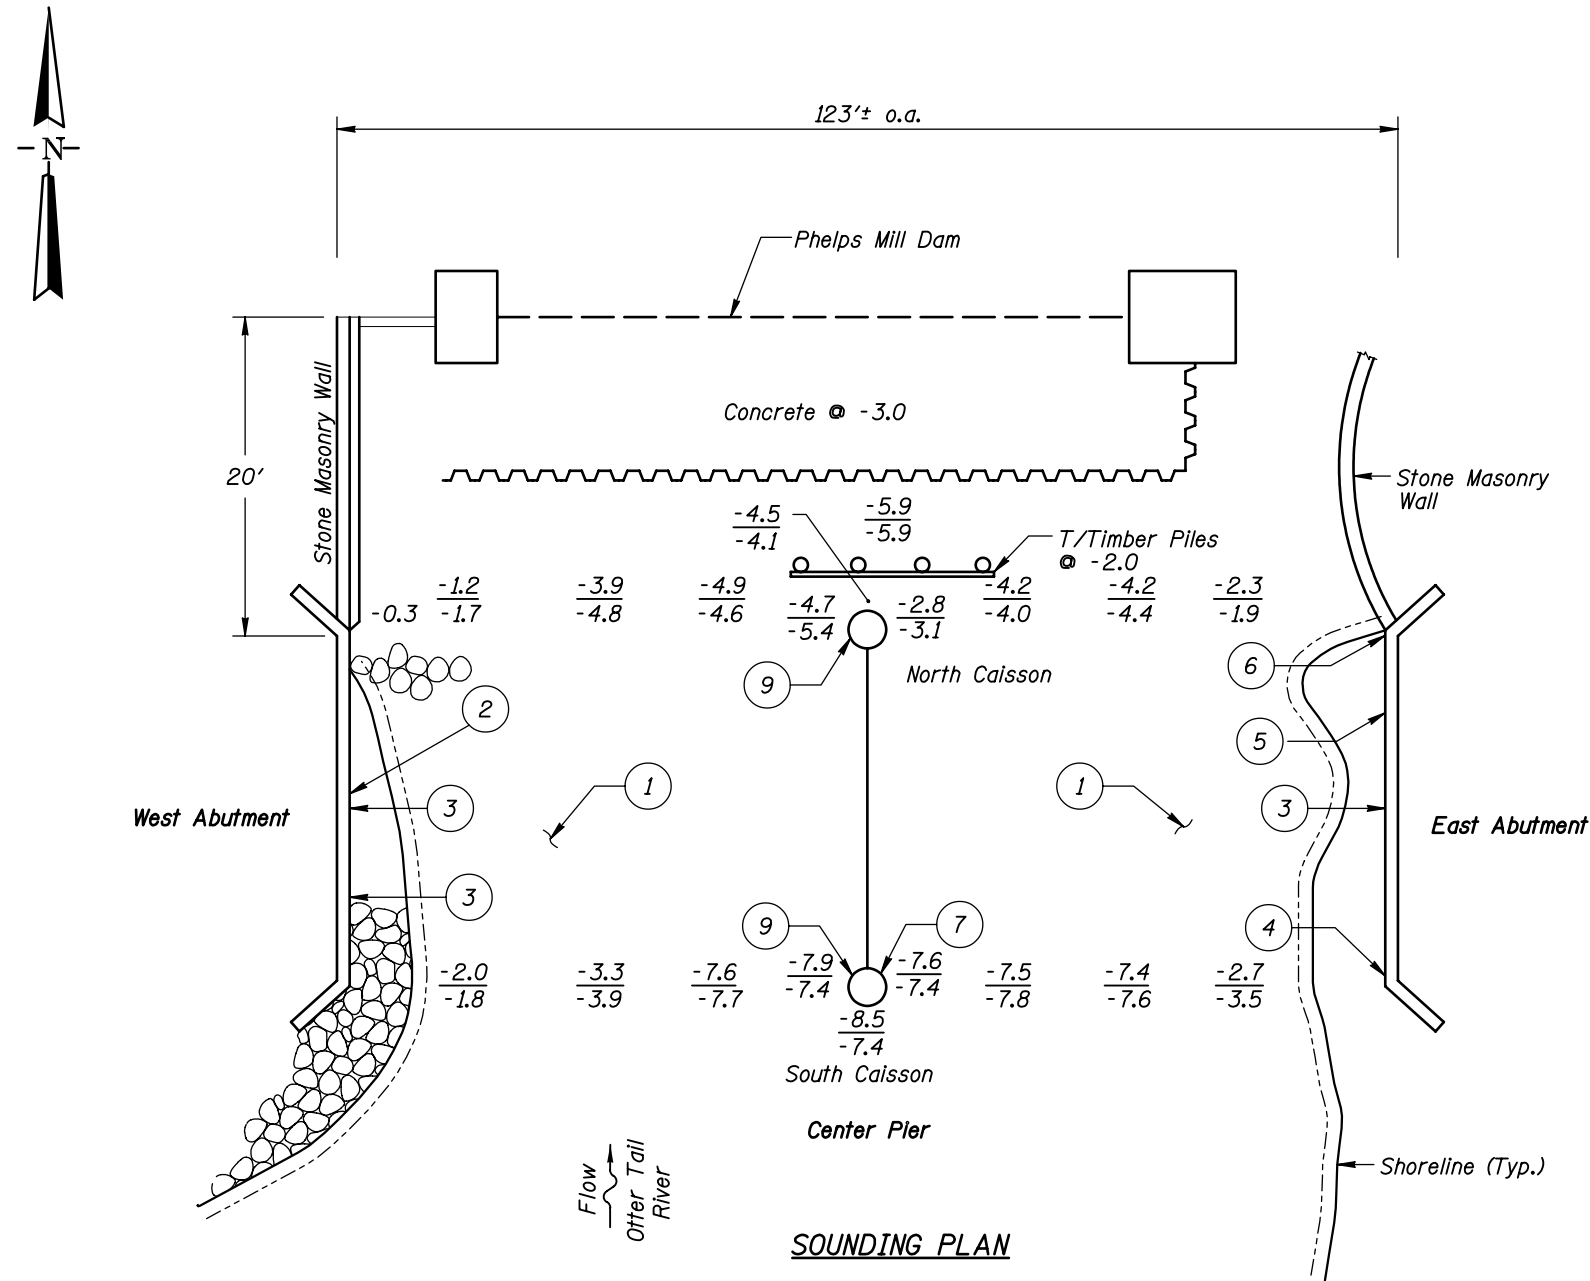
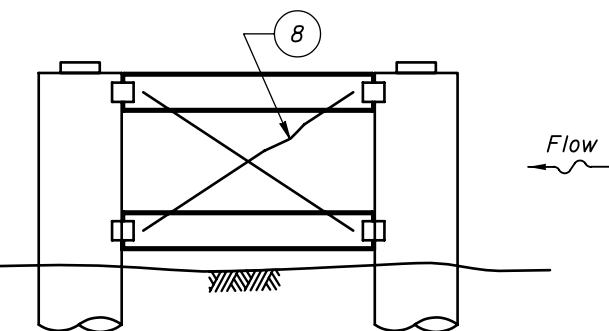
INSPECTION AND SOUNDING PLAN

- 1 The channel bottom material consisted of sandy gravel and scattered 12 inch diameter riprap with 1 to 4 inches of probe rod penetration.
- 2 Approximately 50 percent of the abutment breastwall was covered with 1 inch deep scaling with some areas of exposed reinforcing steel.

- 3 Vertical crack, hairline to 1/16 inch wide, was present extending the full abutment height.
- 4 Vertical crack, 1/2 maximum width, was present extending the full abutment height. In addition, a spall, 1.5 feet wide by 2 feet high with 3 inches of penetration was present at the groundline.

- 5 Vertical crack, 1/16 inch maximum width, was present extending the full abutment height. In addition, a 10 inch diameter spall with 2 inches of penetration was present at the groundline.

- 6 Vertical crack, 1/2 inch maximum width, was present extending the full abutment height. Two spalls with exposed reinforcing steel were also present. One spall was 1.5 feet high by 1.5 feet wide with 6 inches of penetration and was at the groundline. The other spall was 0.5 feet high by 1 foot wide with 2 inches of penetration and was 2.5 feet above the groundline.

- 7 Missing rivet at 11.5 feet below the top of the caisson, causing a 1/4 inch wide by 1 foot long gap in the steel caisson shell.
- 8 Cross bracing extending from the top of the south caisson to the bottom of the north caisson exhibited a minor vertical bend/distortion.

- 9 Both caissons of the Center Pier exhibited 100 percent of coating failure and minor surface corrosion from 1 foot above the waterline to the channel bottom. Overall, the Center Pier also exhibited a detectable differential settlement to the north.

- 10 A horizontal crack, 3/4 inch maximum width, extended the length of wingwall 4.5 feet above the groundline.

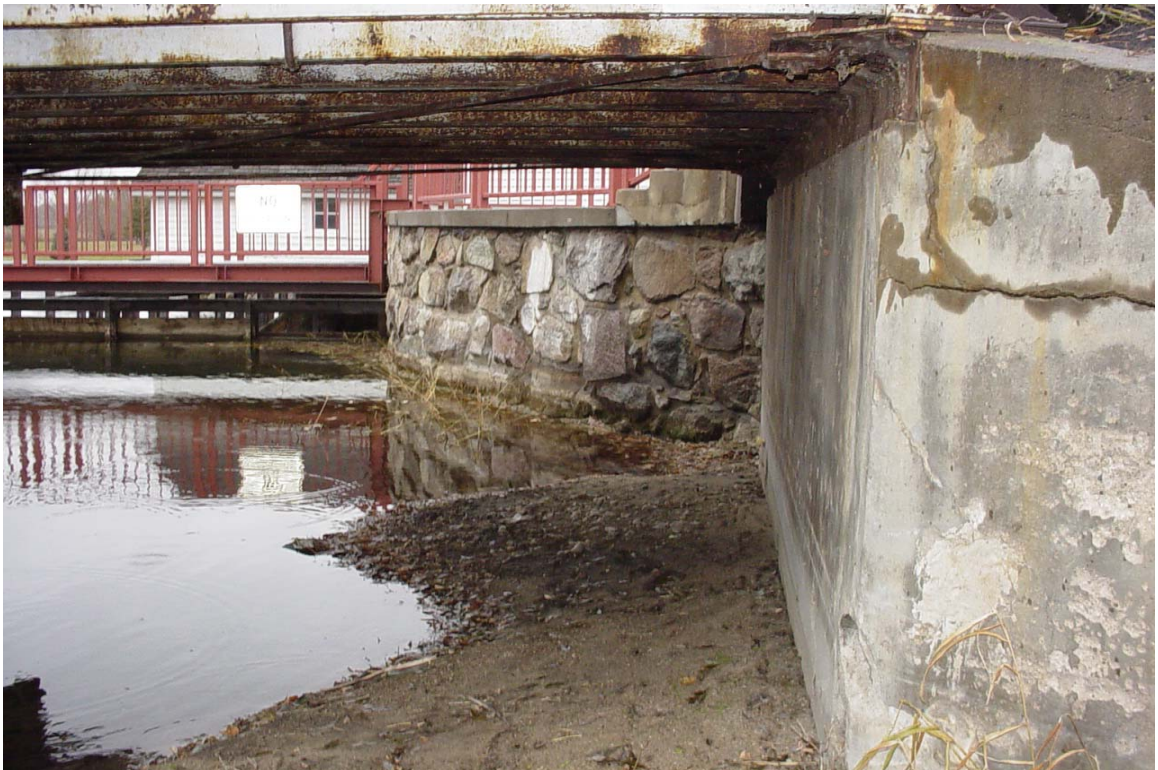
- (D) The East Abutment breastwall exhibited vertical cracking up to 1/2 inch wide and three spalled areas with some exposed reinforcing steel. The spalls were no larger than 3 square feet in area and located near the ground line. None of this concrete deterioration was deemed to be structurally detrimental at this time.
- (E) A horizontal crack with a maximum width of 3/4 inch extended the full length of the South Wingwall of the East Abutment 4.5 feet above the ground line.

Photograph 2. View of East Abutment, Looking North.

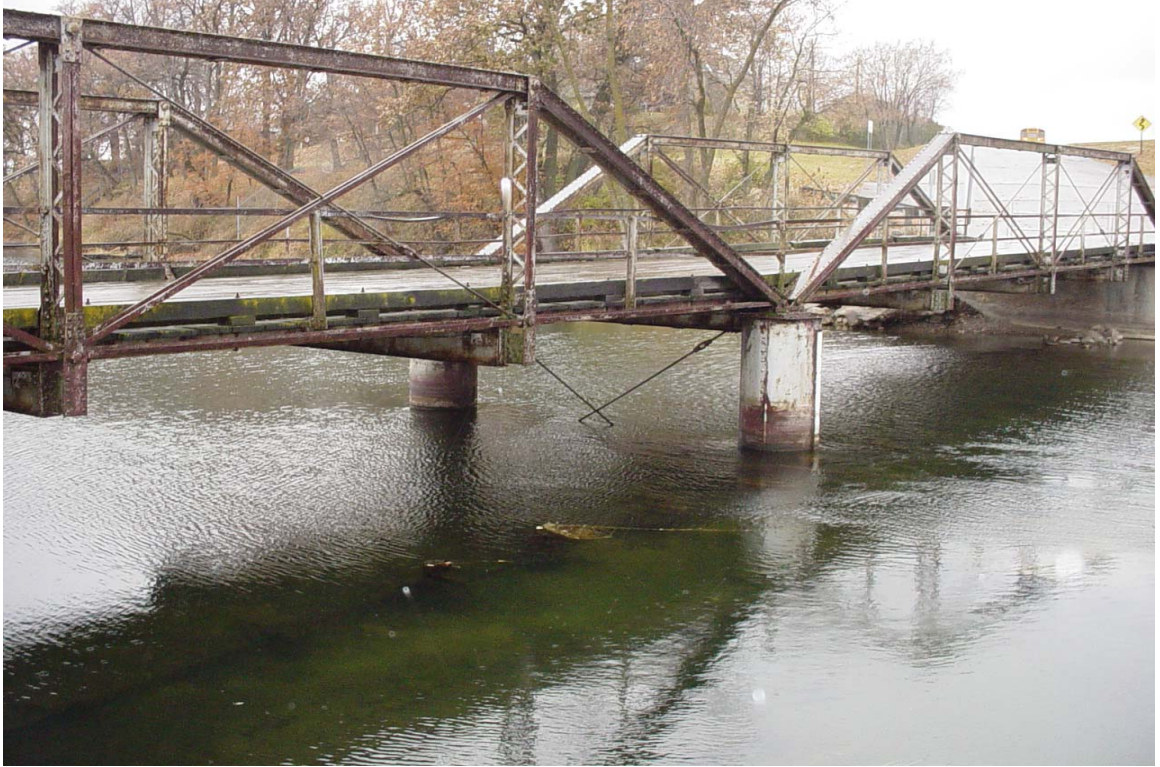
- (A) The south caisson of the Center Pier had a rivet missing below water, causing a 1/4-inch-wide by 1-foot-long gap in the steel caisson shell. Additionally, one steel cross brace between caissons was bent out-of-plane. It was also observed that the Center Pier has overall settled noticeably toward the north.
- (B) The Center Pier caissons exhibited 100 percent coating failure and minor surface corrosion from 1 foot above the waterline to the channel bottom.
- (C) The West Abutment breastwall exhibited random vertical hairline to 1/16 inch wide cracking and widespread moderate to heavy scaling with some exposed reinforcing steel. None of this concrete deterioration was deemed to be structurally detrimental at this time.

Photograph 3. View of the Center Pier, Looking Southwest.

- (A) Monitor the settlement rate of the Center Pier during future inspections, preferably at a minimum interval of one (1) year during above water inspections. If settlement is continuing and is adversely affecting the stability of the structure, measures to stabilize or close the bridge may be warranted.
- (B) Reinspect all substructure units underwater within an interval of three (3) years until the Center Pier movement has stabilized or if the structure is replaced.

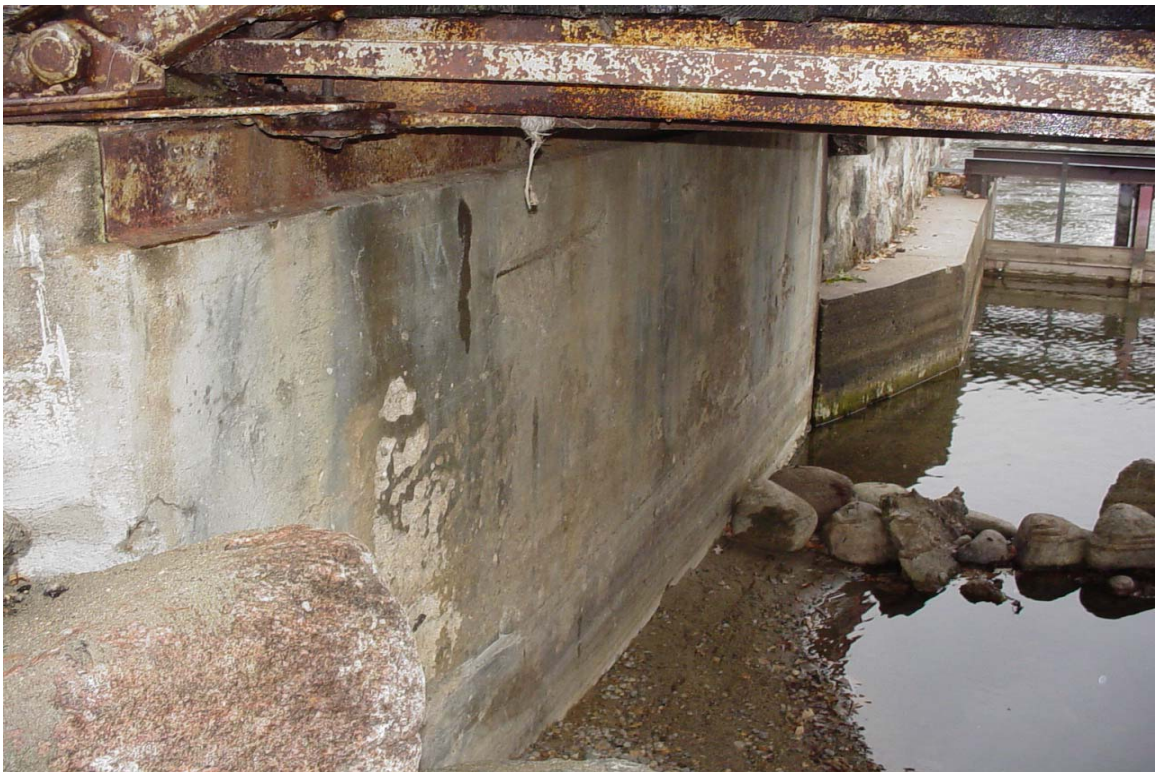
Photograph 4. View of the West Abutment, Looking Northwest.

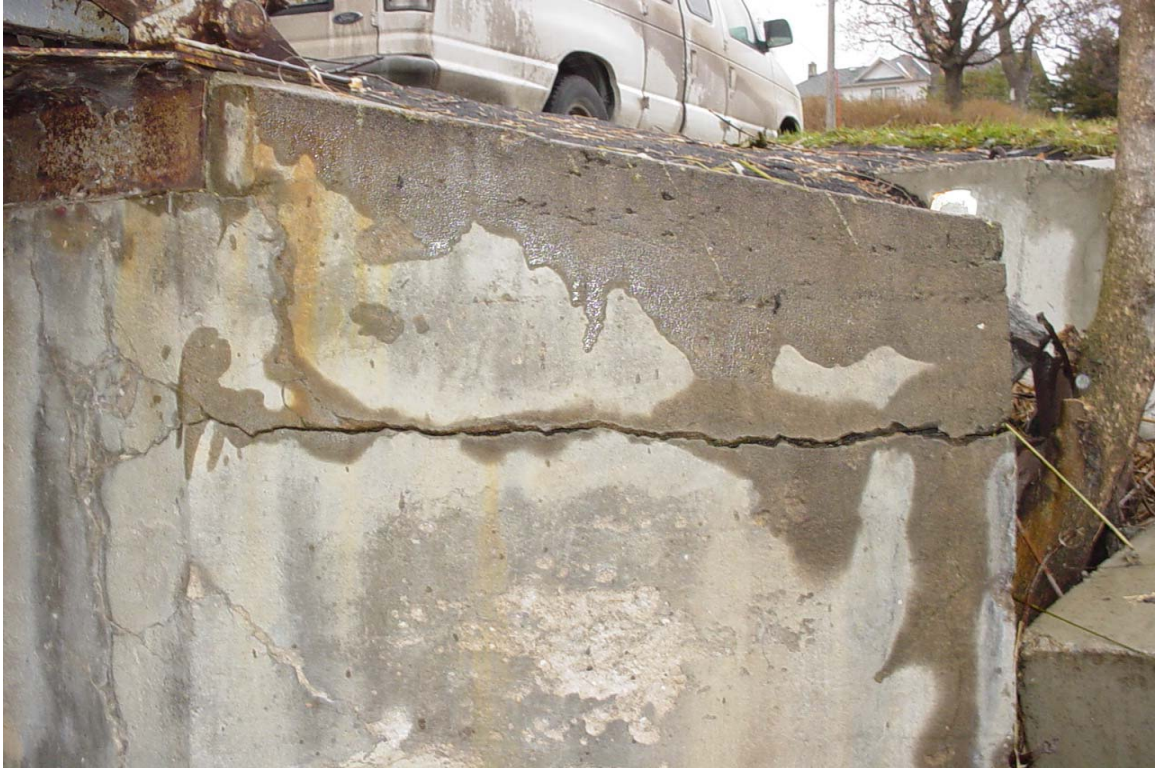
Photograph 5. View of Horizontal Crack in Southeast Wingwall, Looking East.
